1. Introduction

Rune Frederiksen and Olympia Vikatou

2. Description of the Remains of the Theatre

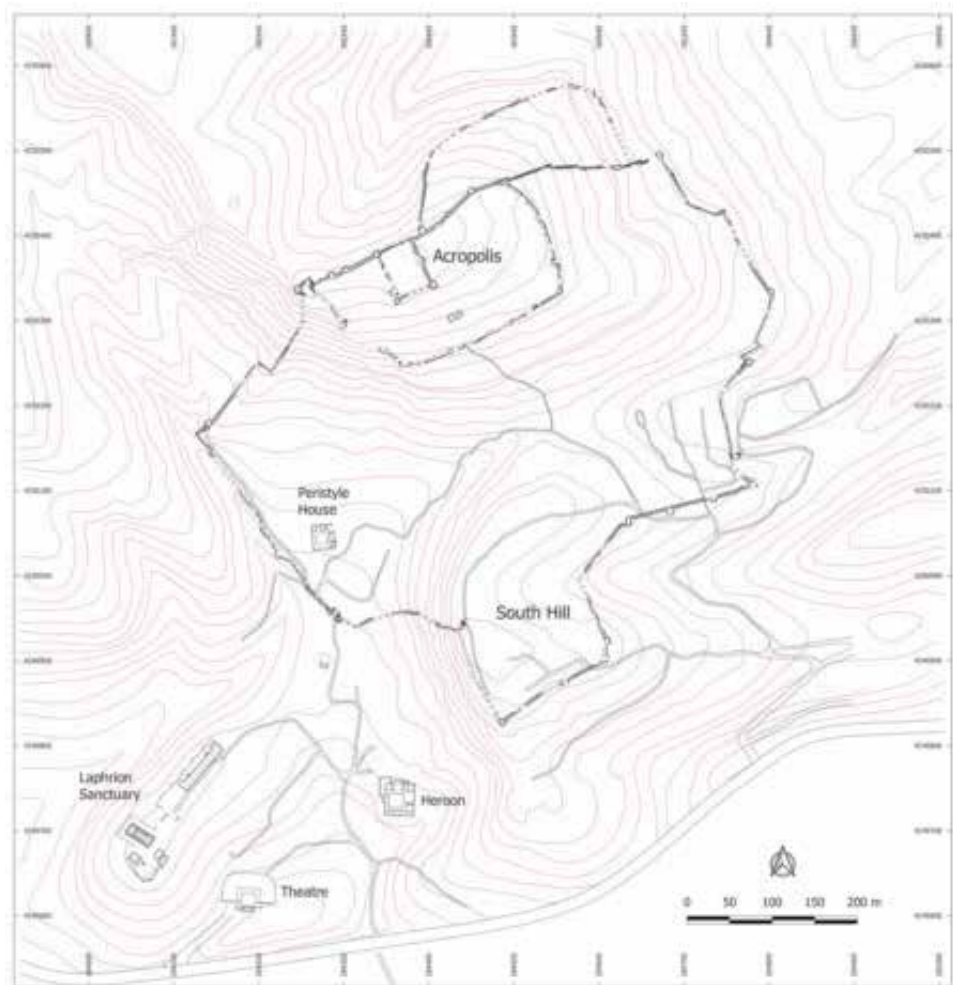
Fig. 1.1 General plan of ancient Kalydon with fortifications and major excavated and studied structures including the theatre. S. Handberg and S. MÜth (fortifications).

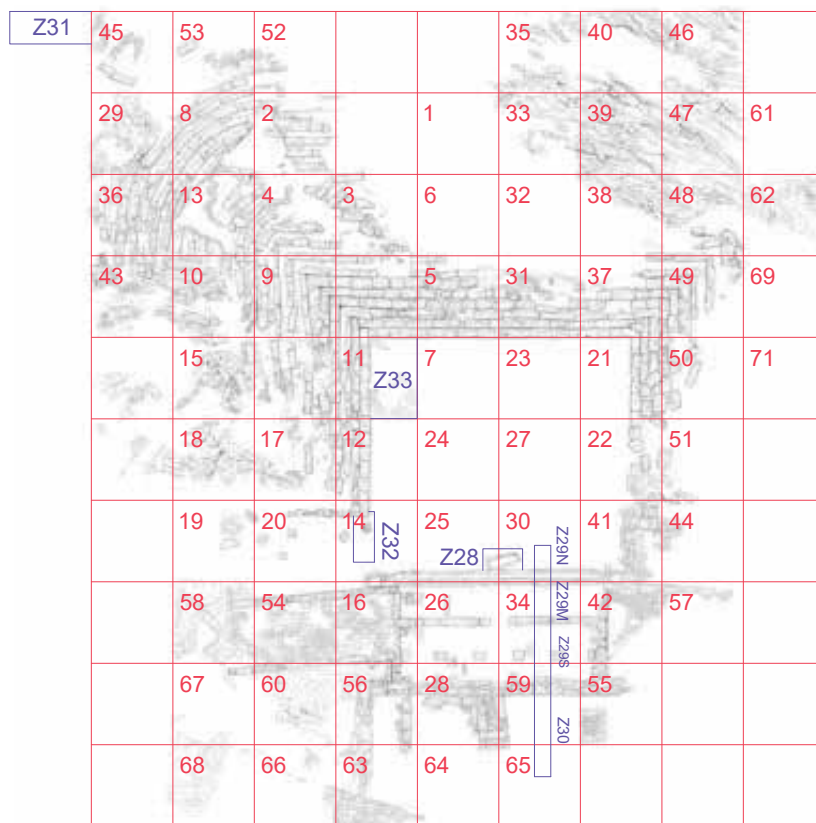
Fig. 1.2 Plan of theatre indicating location of A-trenches 1-71 and Z-trenches 28-33. N. Chatzidakis.

enable a targeted investigation of certain features of the building (Fig. 1.2). The workforce comprised employees of the Ephorate of Messolonghi and the Danish Institute, local workmen and students from five European universities. In 2013-4 restricted parts of the excavation also served as an archaeological field school for Danish university students.⁶

Important observations that give insight into the event, or events, by which the level of the orchestra was raised were made in the sondage Z29/N, in front of the proskenion (Fig. 1.2 and Pl. II.2). As can very clearly be observed on the profile of this sondage, the fill is at this point as deep as 2 m, and made up of five distinct layers, two of fist-sized and smaller stones (Pl. II.2, 3 and 5) and three of very fine and almost sterile soil (Pl. II.2, 1-2, 4 and 6). The same layers of soil and stones were found in the trench in the south-easternmost corner of the orchestra, and at the bottom of the Byzantine grave 1.5 m west of Z29/N (the uppermost stone layer identified in Z29/N was used as the bottom of the grave – here at 29.40 masl). We have reason to believe that these five layers (or some of them) exist in all areas of the orchestra which needed to be raised – and not only where we happen to have dug the trenches. Since the lowest and middle layers of soil are identical, they are likely to have been filled in at the same time, with the lowermost layer of stones placed in between. The uppermost layer of stones consists of on average slightly larger stones but may also have been filled in at the same event. These stones are also of the local flysch (identical with the bedrock here, too), the same as that used for the stone seats and the scene-building. Other smaller river boulders were mixed in with the stones of both layers.

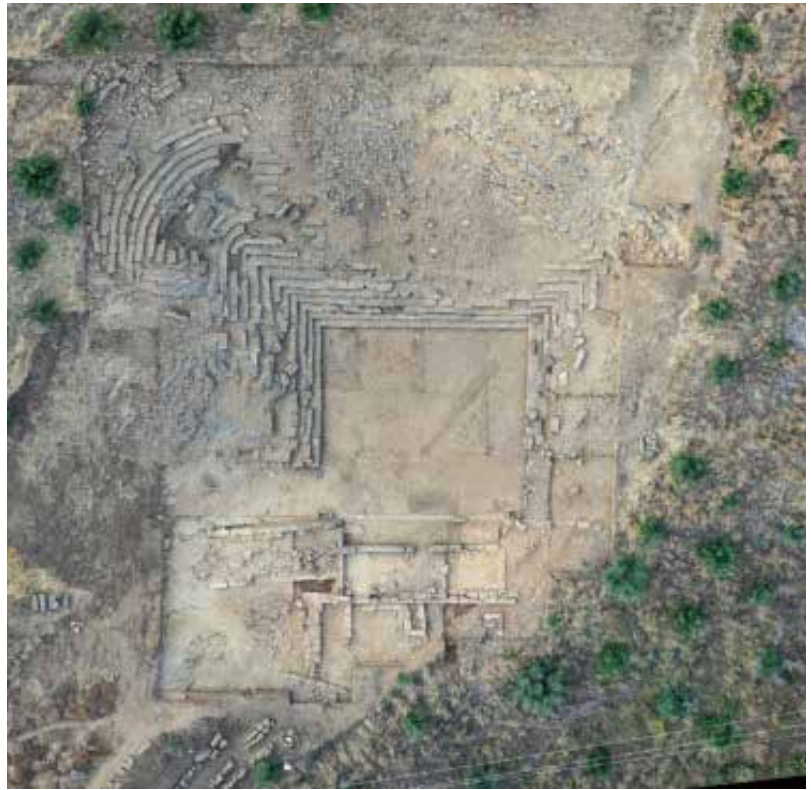
Fig. 1.3 Theatre from above. North is up.

Description of the remains (Pl. I.3 and Fig. 1.3)

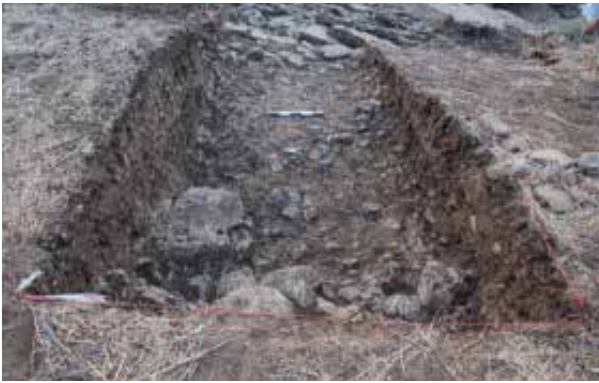
Fig. 1.4 Search trench Z31 in NW-most corner of the koilon seen from the west. Discontinuation of regular stone blocks for seat rows is evident.

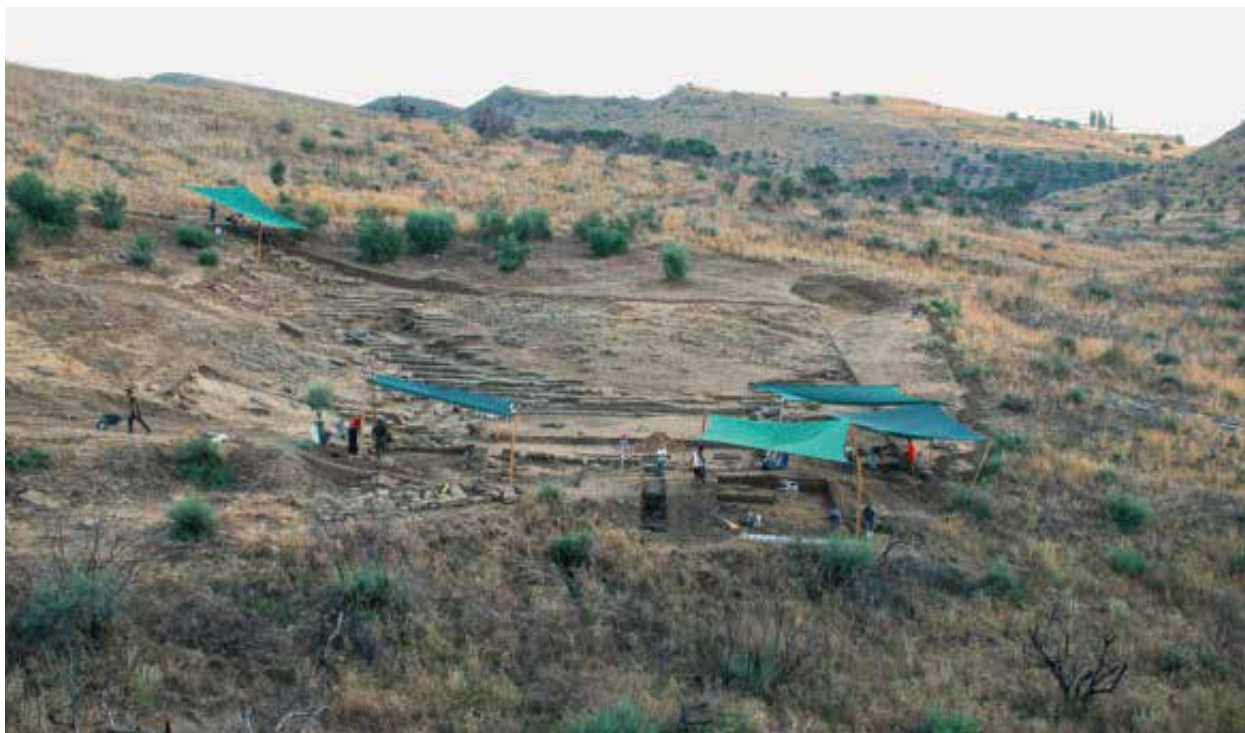
Fig. 1.5 Excavation in progress, July 2012. It is clearly visible how the exposed layers of bed rock are responsible for the shape of the hill side and how they continue sloping downwards in eastern direction beyond the excavation.

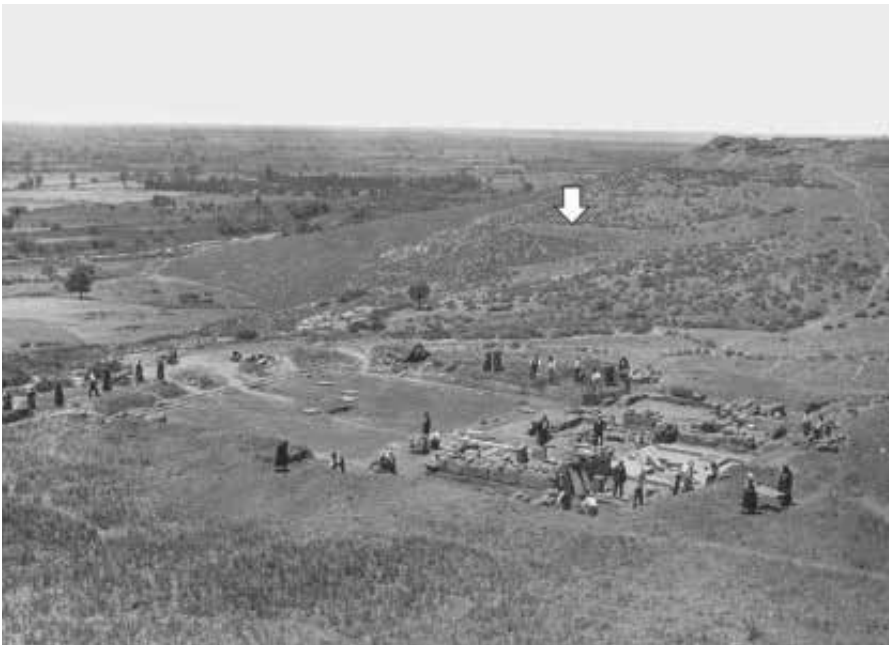
Fig. 2.a.1 Photograph showing the Heroön and the Laphrion (upper right) under excavation in 1932. Approximate location of theatre indicated by arrow. The photograph shows the local topographical situation before the construction of the now old highway (Nafpaktos-Agrinio) in the 1960s. From the north-east.

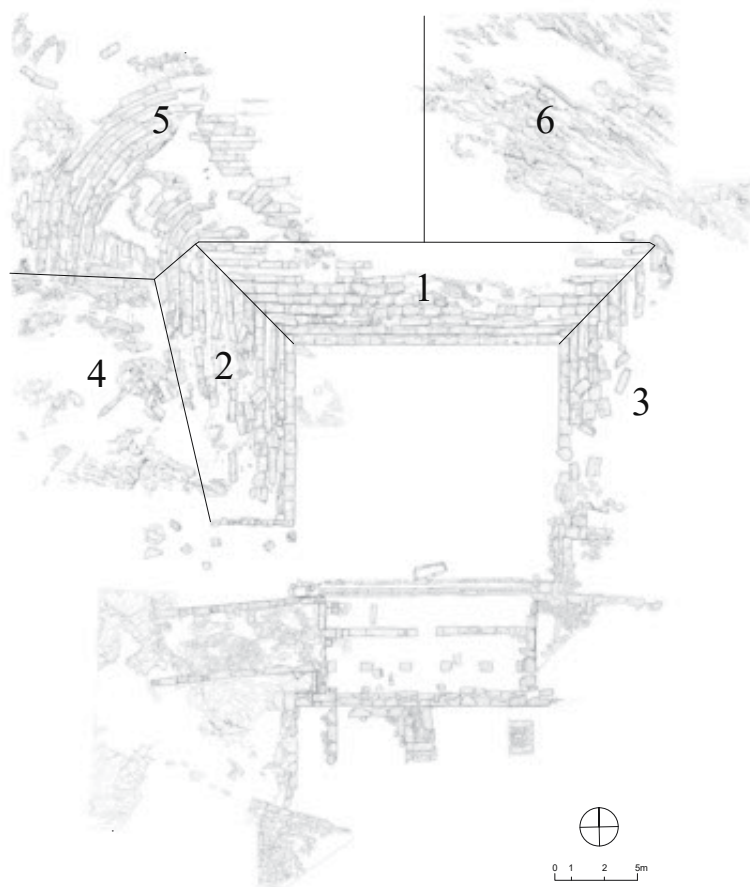
Fig. 2.a.2 Division of the koilon into parts to facilitate description: 1: central, 2: western, 3: eastern, 4: upper western, 5: upper north western and 6: upper eastern. N. Chatzidakis.

The eastern part of the koilon is an artificially built mound (Fig. 2.a.2, area 3), large parts of which have collapsed or sunk; some of this collapse may have happened in antiquity, and some later due to a road that was once constructed at this point (visible on Fig. 1.1). It is obvious from looking at the morphology of the hillside, that bedrock sits far below the needed level in the entire eastern part. Here not only firm foundations would have to be made for the

A third situation is found in the upper central part of the koilon (Fig. 2.a.2, eastern part of upper western part (5), no. 3 on Pl. I.2), a chaotic mass of broken stone blocks, with no apparent order to them, and mixed with soil. It can be observed, here and there, that bedrock has been worked to receive blocks, for example at a point just east of the cen-

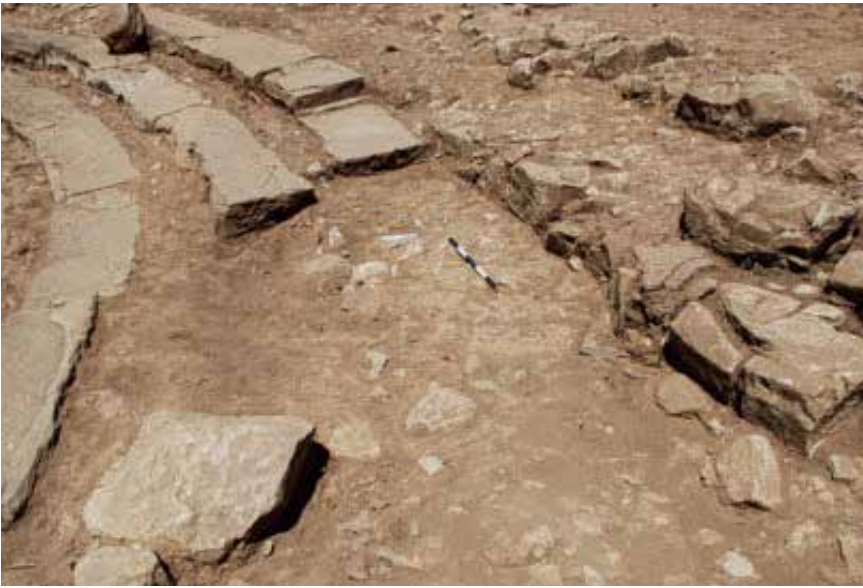
Fig. 2.a.3 Detail of foundation for seat-row in upper centre west part of koilon. From the east.

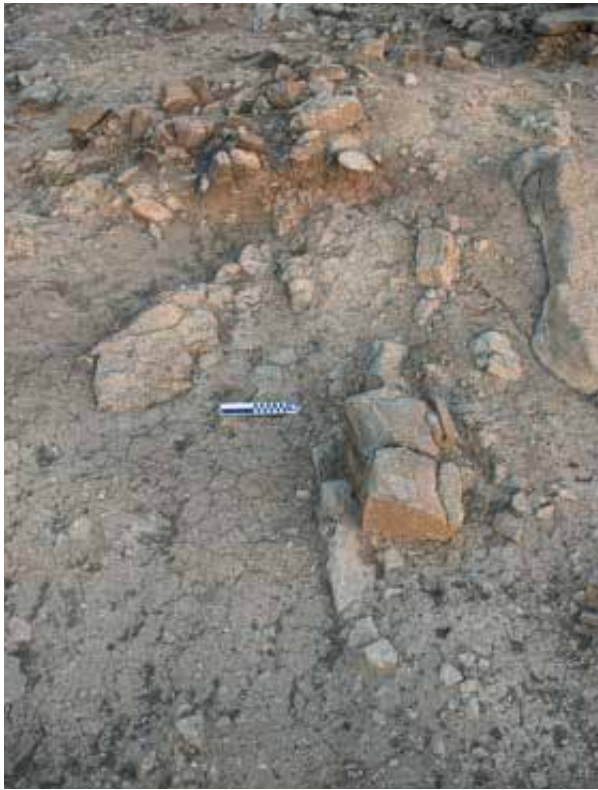
Fig. 2.a.4 Detail of koilon in upper centre east part. Foundation for seat-row cut in bed rock. From the east.

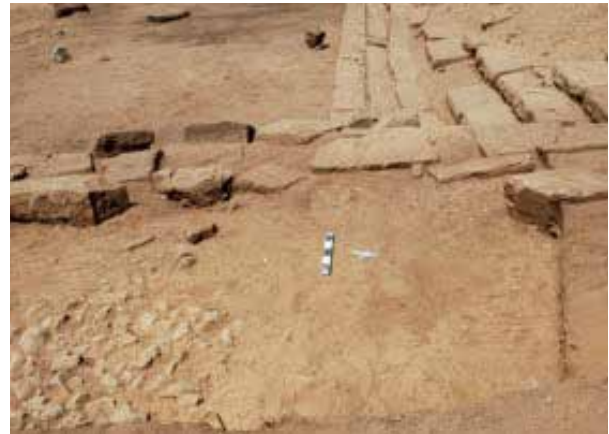
Fig. 2.a.5 Excavation in progress in the East Wing. Upper center with rows of seat blocks having slid out of place downwards is visible as is the fill of the East Wing, soil and stones, to the lower left. From the east.

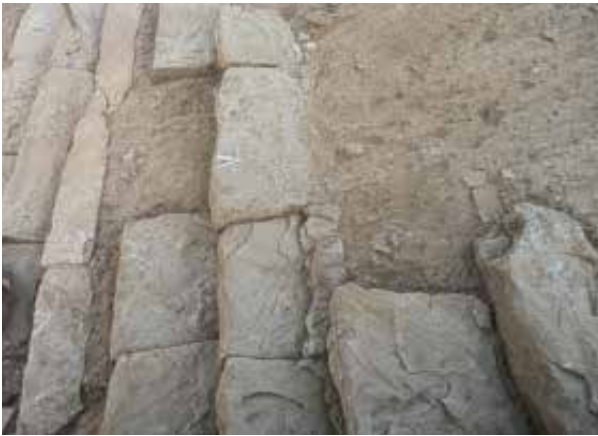
Fig. 2.a.6 Detail of koilon. Nature of preservation and weathering of seats blocks in lower east half of central area. Flaking obvious on blocks IV.27 and 28. From the east.

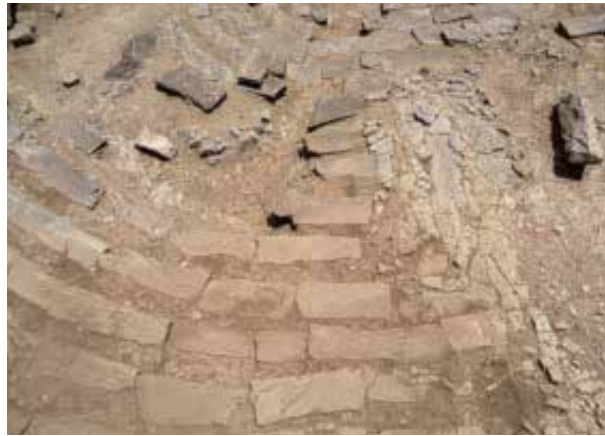
Fig. 2.a.7 Detail of upper west part of koilon showing bed rock just south (on the right) of rows XIII-XXI. From the west.

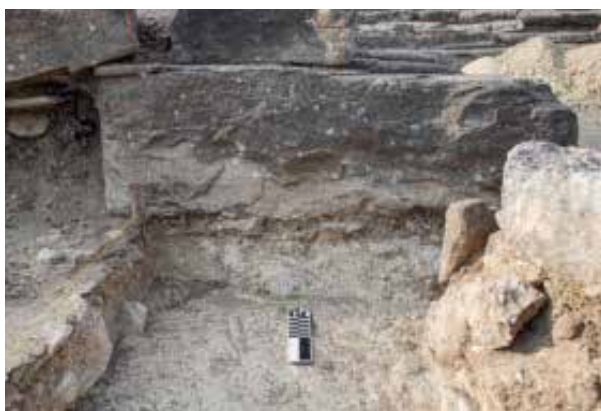
Fig. 2.a.8 Search Trench Z32 with basin/mortar in West Parodos, seen from the south. Block I.1 (= block 1 of WA) visible in the centre, mortar to the right and square void visible just left of Block I.1.

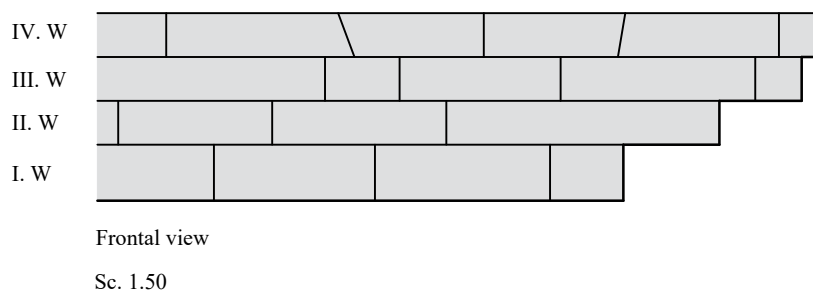
Fig. 2.a.13 Stylized drawing of view from above of blocks in seat-rows I-IV. N. Chatzidakis.

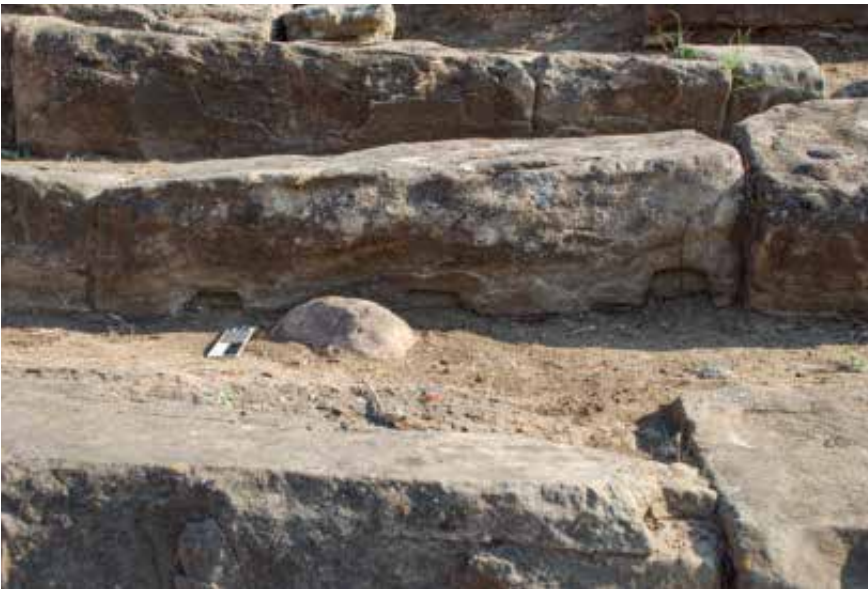
Fig. 2.a.14 Seat blocks in koilon with wedge-marks after quarrying preserved. From the south.

Row VII (VII.1-23): c. 50 % of the blocks are preserved. They are of the long and narrow type, like in Rows II–III; for dimensions see Table. 1. Many are no longer in situ but have slid down and into the space of Row VI. Some blocks meet in obtuse joints (as in Rows III and IV). Wherever blocks of this row and the one above (VIII) are in situ there is a clear space between them, filled with soil and stones, like the one observed between III and IV, though this one is wider. The corner of block VII.9 (towards the filled space) has been cut, like the corners of blocks III.7 and III.16. Block VII.19 – the equivalent of III.16 – is furnished with a rounded corner, producing the same effect as the cutting of block VII.19. Block VII.18 has a shallow rectangular cavity, 8 x 18 x 1-2 cm (Fig. 2.a.14).

this row and Row IX, like the ones between Rows III–IV and VII–VIII. Oblique fitting is observed. Blocks VIII.3-4 have wedge-marks from the quarrying preserved on their inner edges towards Row IX (Fig. 2.a.14).

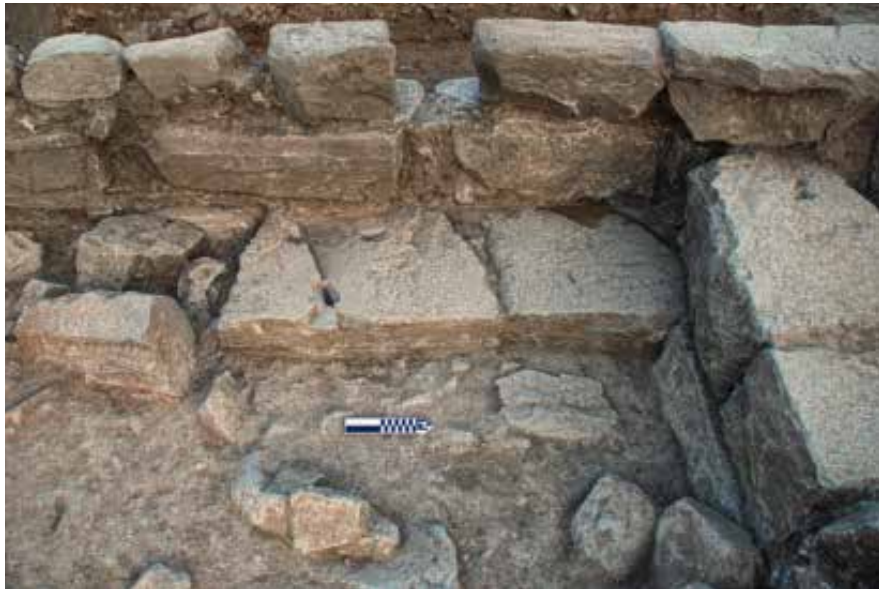
Fig. 2.a.15 Analemma I (East Analemma), on the right. Orchestra terrace wall in upper center with AS31 below.

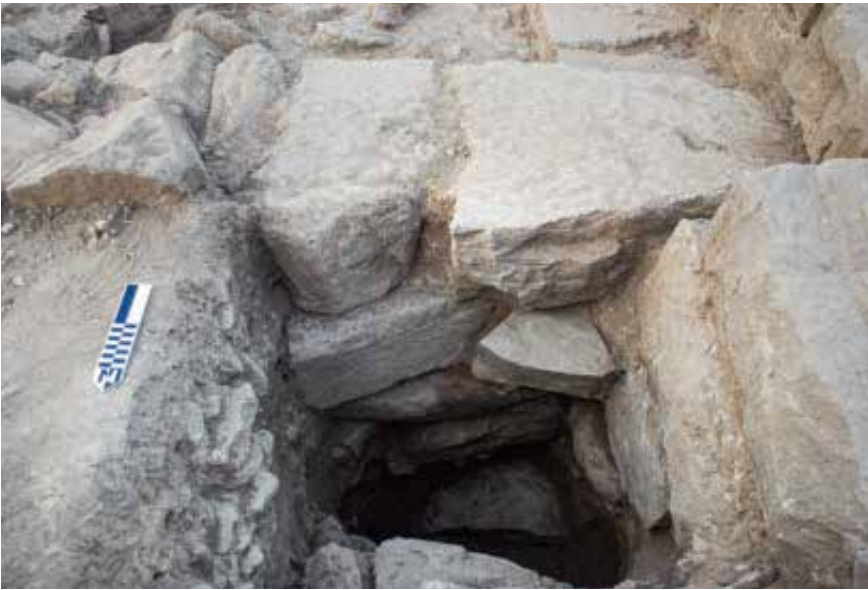
Fig. 2.a.16 North (inner) face of East Analemma. Bed rock visible on bottom of sondage. From the north.

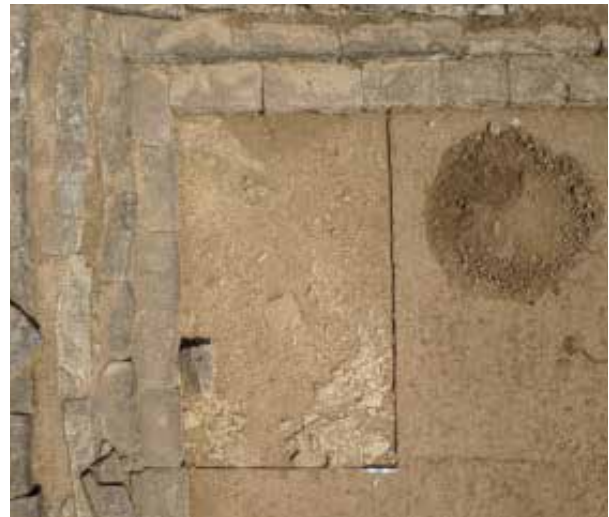
Fig. 2.b.1 Search trench Z33 in NW corner of orchestra. Bedrock is exposed. One displaced stone block from koilon in lower left corner of trench. North is up.

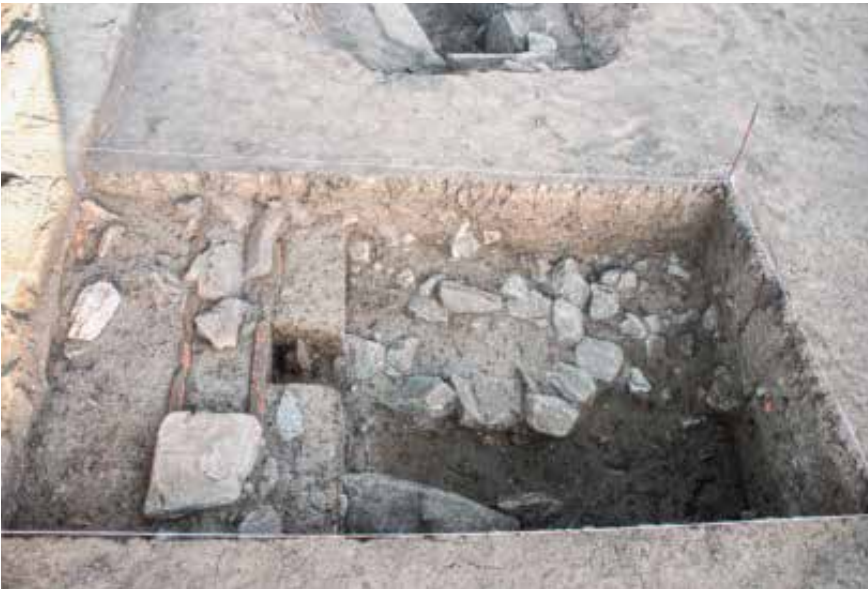
Fig. 2.b.2 Search trench Z29/N north of the proskenion (visible to the left). The Byzantine cist grave in Z28 visible above. From the east.

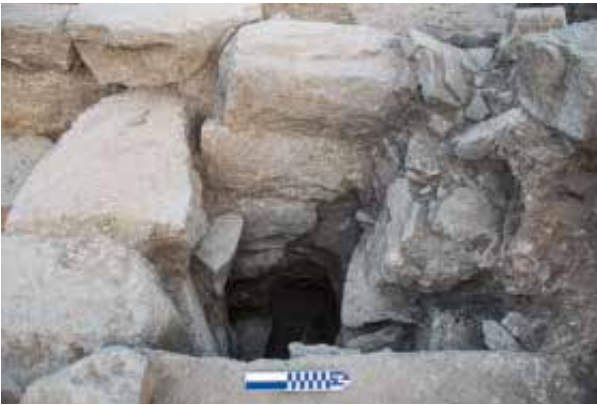
Fig. 2.b.3 East Wing Ash Pit/Context EP.5 under the proper location for block I.36 (which is not in situ). The East Analemma (AS29) is visible to the left and the Orchestra Terrace Wall in upper part of picture. From the east.

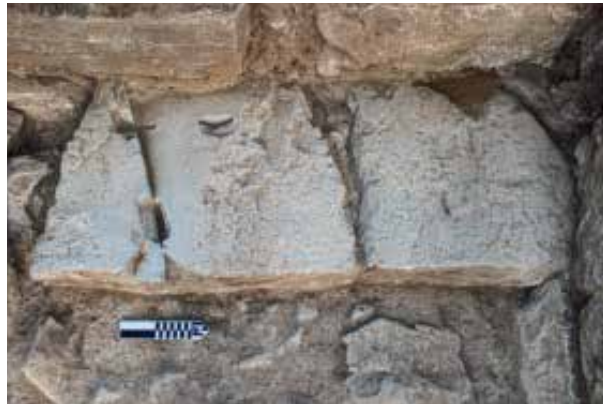
Fig. 2.b.4 AS31 seen from the east. Above the lowest part of the Orchestra Terrace Wall is visible.

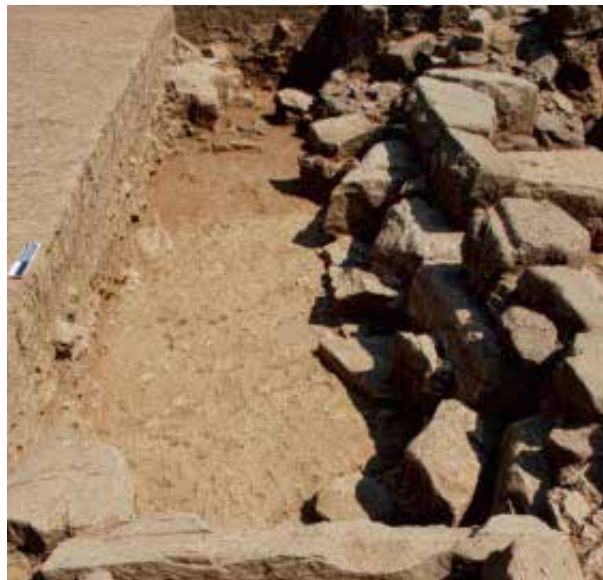
Fig. 2.b.5 Trench A41W with the Orchestra Terrace Wall (on the right) seen from the south. East Basin just visible in the foreground.

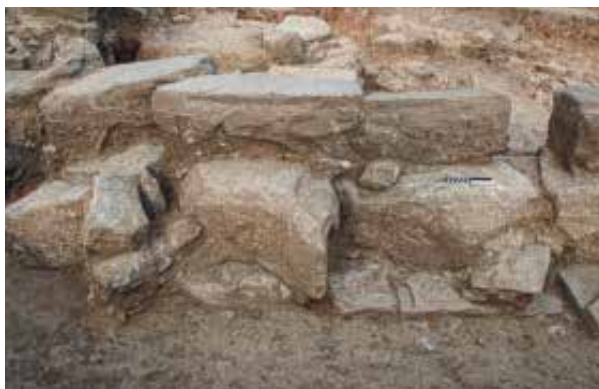
Fig. 2.b.6 Trench A41W with Orchestra Terrace Wall seen from the west. Drafting to mark the level of the orchestra level at upper edge of blocks is visible.

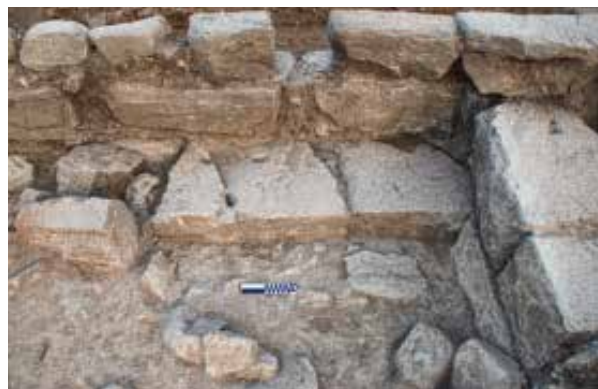
Fig. 2.b.7 Orchestra Terrace Wall behind and slightly overlapping AS31. AS29 is visible to the right. From the east.

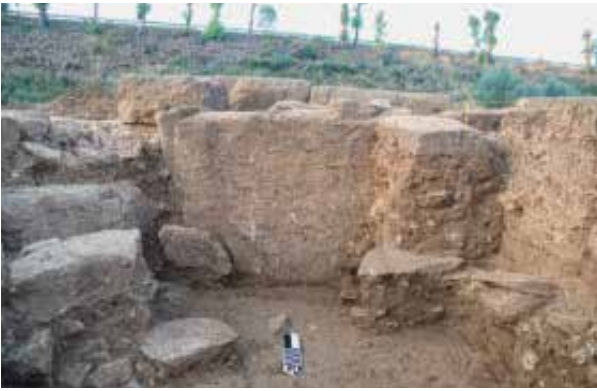
Fig. 2.b.8 North side of East Water Basin seen from the north. On the left the Orchestra Terrace Wall and behind the East Ramp North Wall are visible.

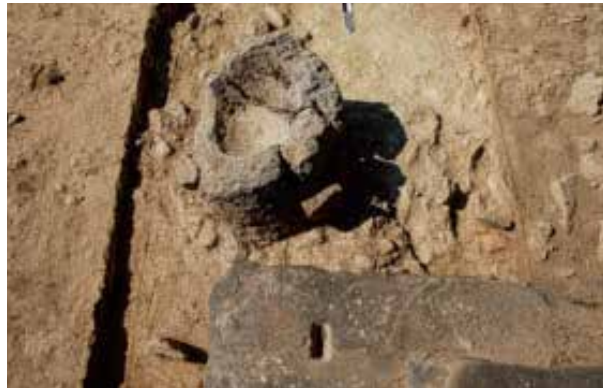
Fig. 2.b.9 Search trench Z32 with mortar and, below, Block I.1 of the koilon. From the north.

At the border between the west parodos and the orchestra, close to the inner western corner of the koilon, a fragmentary monolithic stone basin or mortar was found (H: 30 cm, D: 70 cm, inner D. at bottom of cavity: 17 cm, upper D. of cavity

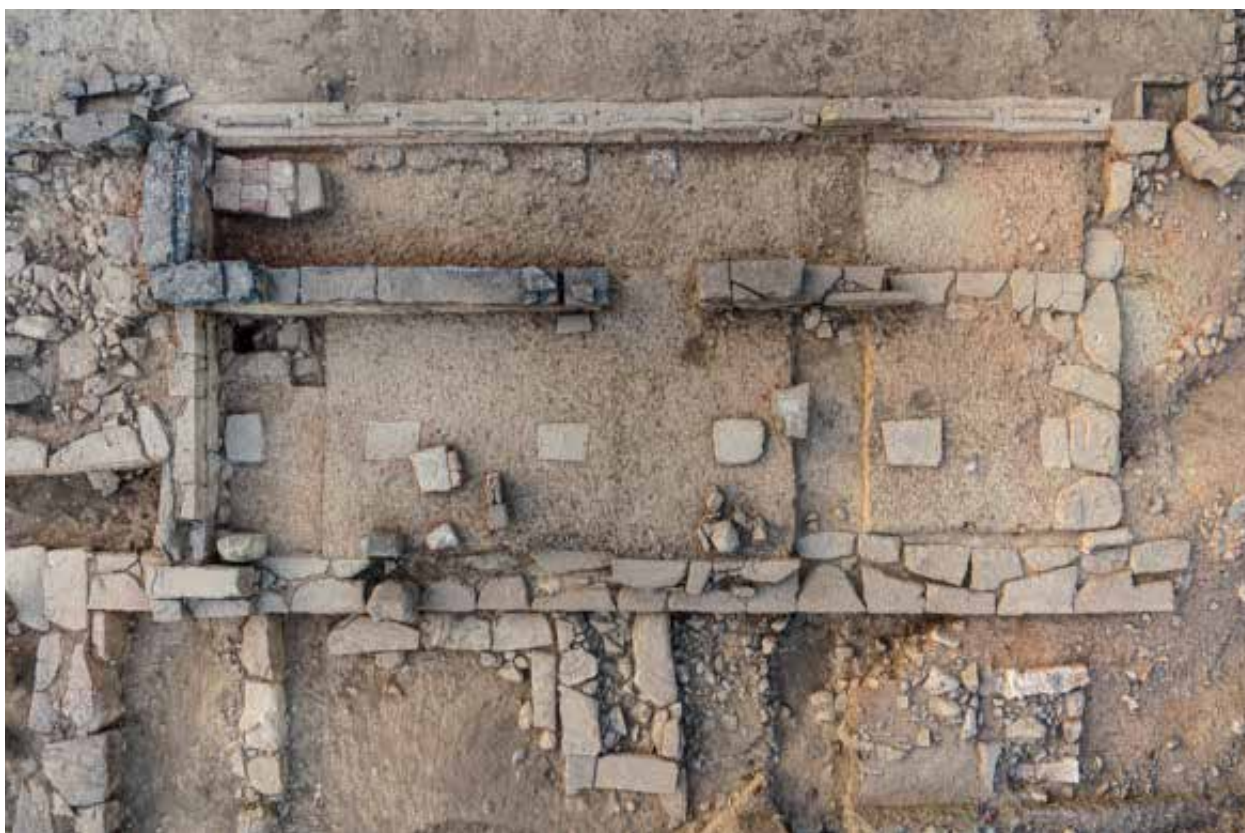
Fig. 2.c.1 Scene building from above. North is up.

The skene is a rectangular structure built of the local sandstone and measuring 12.12 x 3.40 m (41.2 m²), delimited by the walls SkEW (Skene East Wall), SkWW, SkNW and SkSW (Pl. I.3; Fig. 2.c.1). As was the case with the koilon, the western part is better preserved than the eastern; the walls in the western part are preserved to a height of some 80 cm or three courses of masonry (above the ancient level), while in the east (SkEW) only the stones forming the uppermost course of the foundation, finishing approximately at the point of ancient floor level, are preserved (Pl. II.2, with indication of ancient floor

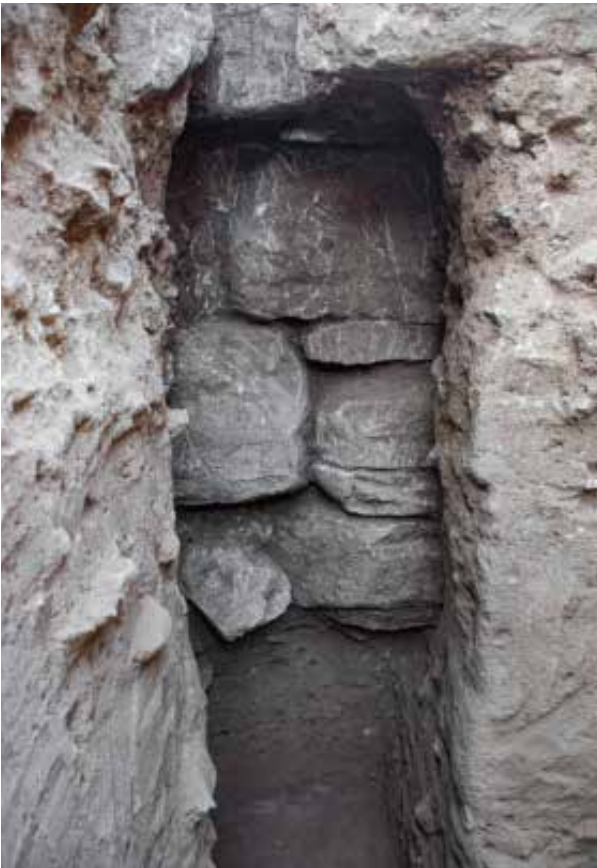
Fig. 2.c.2 Lowest courses of Skene South Wall. From the north, inside the skene, at Z29S (NS section).

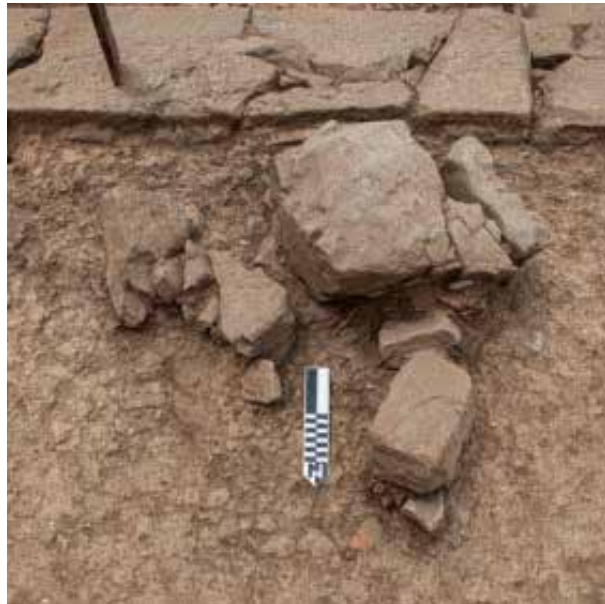
Fig. 2.c.3 Stones and tiles up against the Skene South Wall. Drafted edge visible on blocks in SkSW.

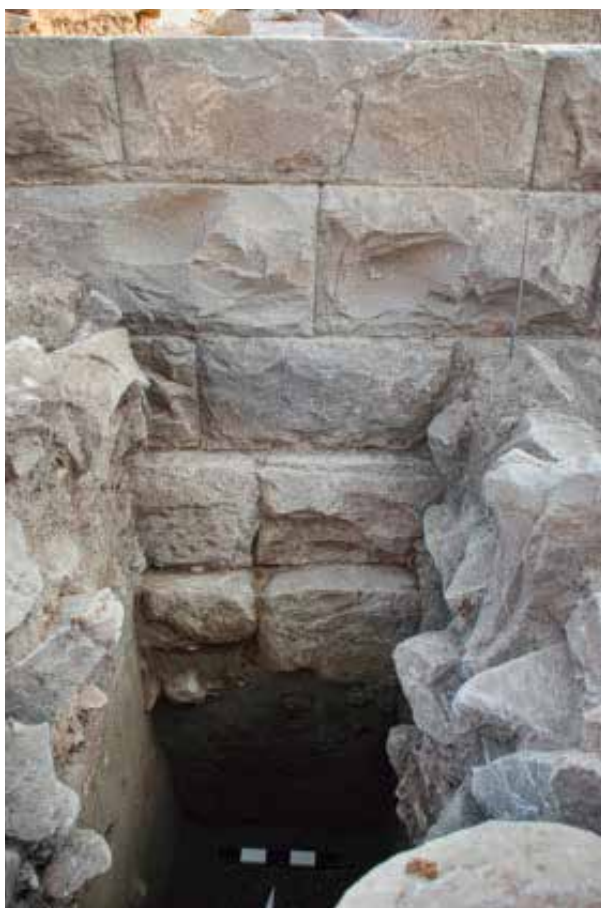
Fig. 2.c.4 Scene Building South Wall from the south at Z30 (NS section).

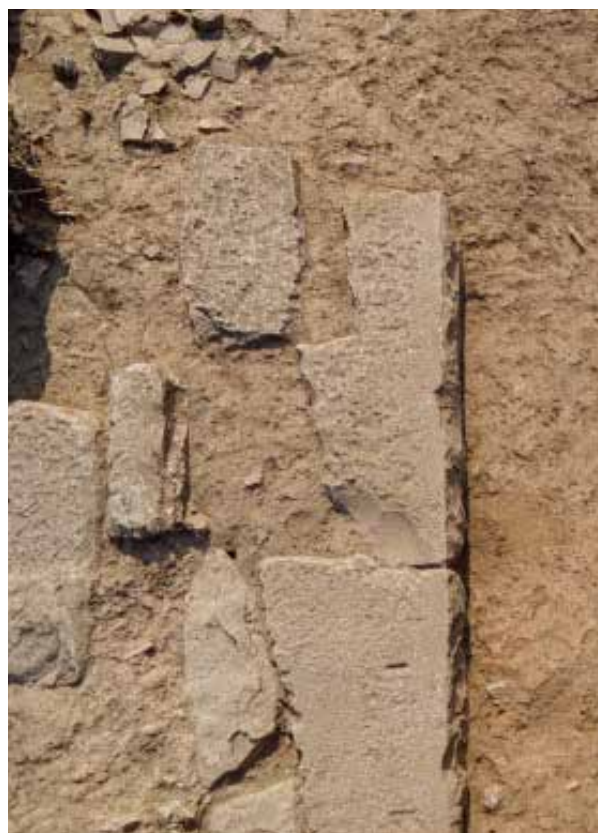
Fig. 2.c.6 Skene East Wall and Skene South Wall seen from above (east is up). The end of SkSW and SkEW abutt, southernmost stone of the latter is markedly small and of porolithos.

The SkEW runs from the SkSW and up to the corner where the ERNW meets the east end of the proskenion stylobate; its part north of the SkNWE is called the PEW (Proskenion East Wall)/ERWWN (East Ramp West Wall North) which is c. 57 cm wide. The SkEW abuts the SkSW and is overlapping the proskenion stylobate (Figs 2.c.1 and 2.c.18). It is very substantially built of one row of large stone blocks (Fig. 2.c.5), positioned with their regular flat sides towards the east and irregular sides towards the west, which were the inside and filled foundation side of the skene respectively. The blocks are finely dressed on the surface to receive further blocks for an unknown number of now lost courses above. The uppermost row of blocks preserved are those forming the last course of the sub-ancient floor level – the next (lost) course would have been the first course of the wall above ground level. The stone blocks of (the foundation of) the SkEW are substantial, some being as wide as 1 m, 46-48 cm high and one block as long as 1.34 m. The southernmost stone of the SkEW (Fig. 2.c.6) is considerably smaller than the rest of

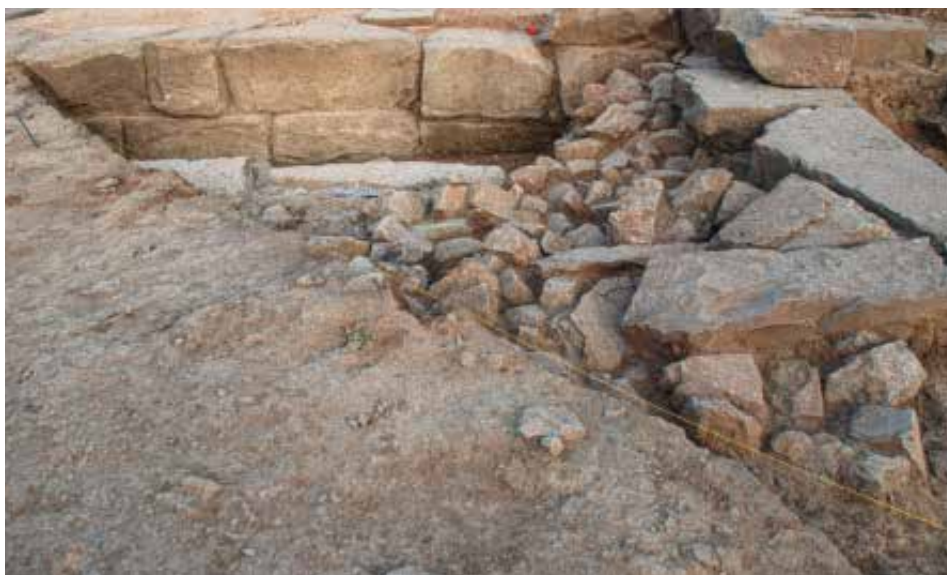
Fig. 2.c.5 Skene East Wall seen from the east with East Ramp fill in foreground. East Ramp North Wall on the right.

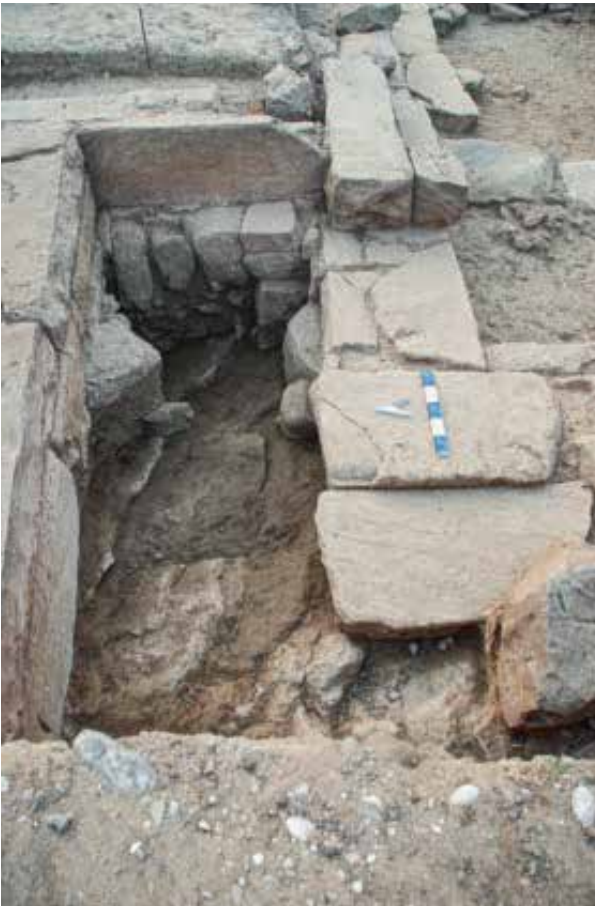
Fig. 2.c.7.1 The exterior face of Skene West Wall with foundation, soil with stones and bed rock beneath (after removal of context A56NW.5). In the foreground on the right the west end of the Skene South Wall, on the left the West Ramp South Wall. From the west.

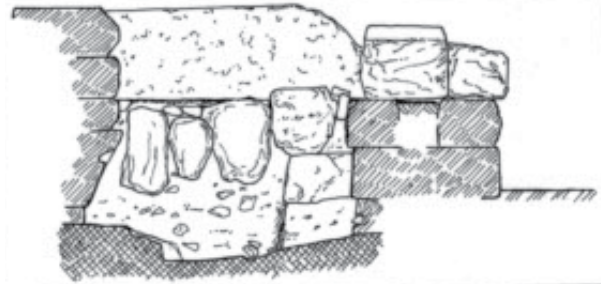
Fig. 2.c.7.3 Elevation of Skene West Wall seen from the west. N. Chatzidakis.

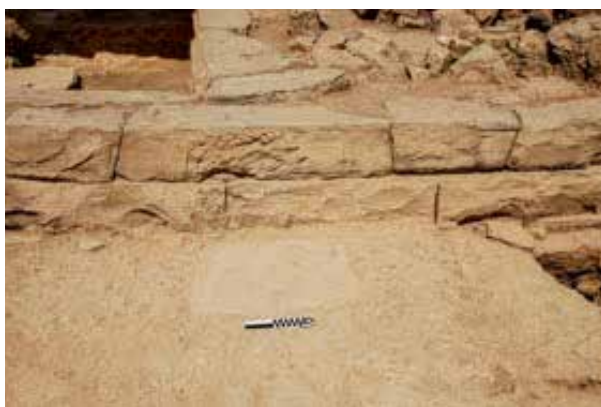
Fig. 2.c.8 The interior face of Skene West Wall with roughly smoothed part over Skene Column Base 1. From the east.

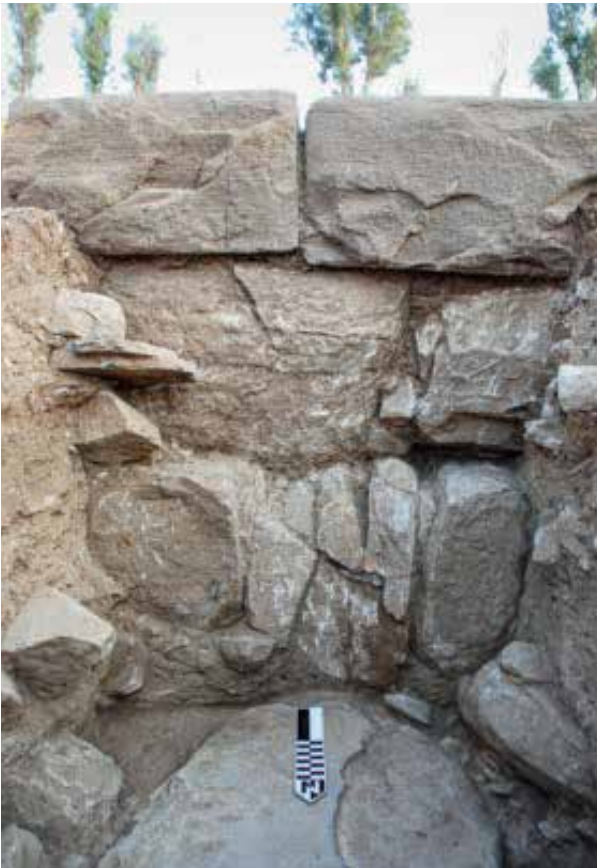
Fig. 2.c.10 North face of socle for Skene North Wall East at Z29/M.9, from the north.

known at the point of the North–South section (Pl. II.2 and Figs 2.c.9-10). They are both constructed as a single shell of shallow rectangular stone blocks above the ancient floor level on a foundation of a double-shelled wall below, consisting of two to three courses of flattish blocks set edge-up. This two-

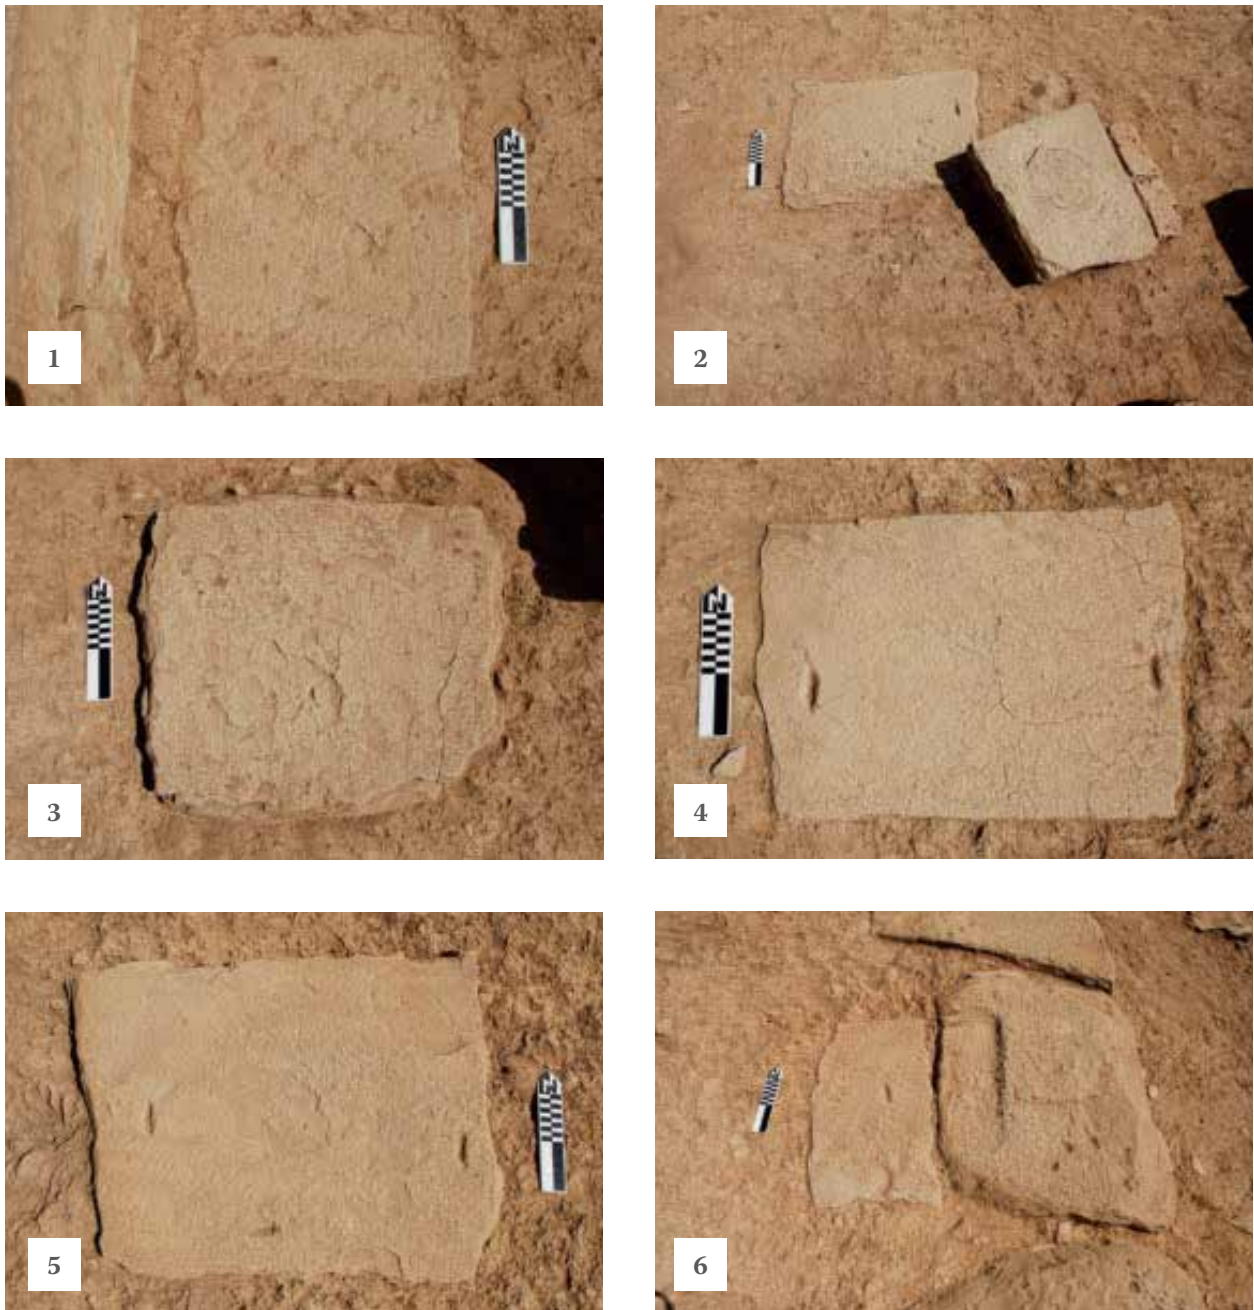
Fig. 2.c.11.1-6 Skene Column Bases 1-6. From the south.

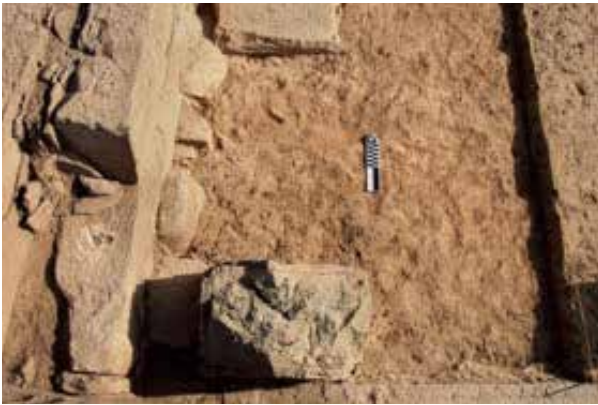
Fig. 2.c.12 Westernmost stone block up against Skene South Wall. In top of photograph Skene Column Base 1. From the south.

Two stone blocks were found placed close to the SkSW opposite the two westernmost stone bases (SkCB 1 and 2), while a third (not in situ) was found opposite the fourth plinth (Pl. I.1, Fig. 2.c.1 and Fig. 2.c.12, the westernmost block).²⁴ The westernmost block is in situ and measures 43* x 45 x

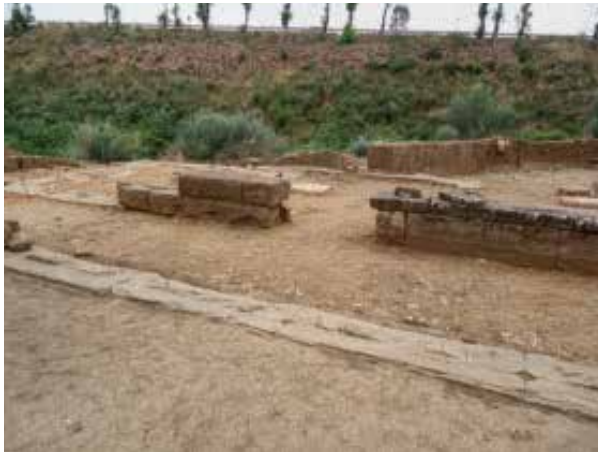
Fig. 2.c.13 Scene building with central part of proskenion stylobate visible in foreground. Seen from the north.

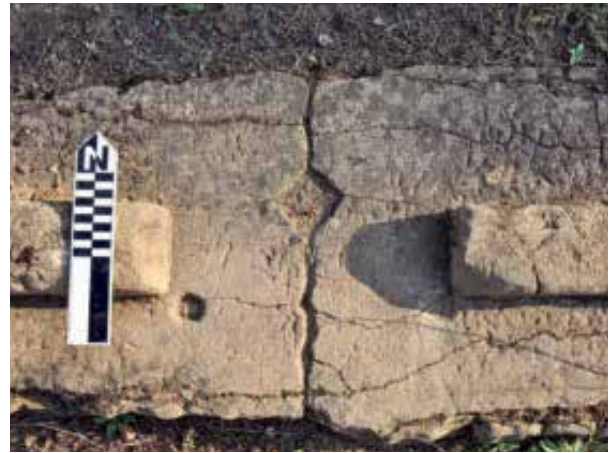
Fig. 2.c.14 Detail of proskenion stylobate showing the structure and colour of the sandstone and surface treatment as preparation for installation of pilaster.

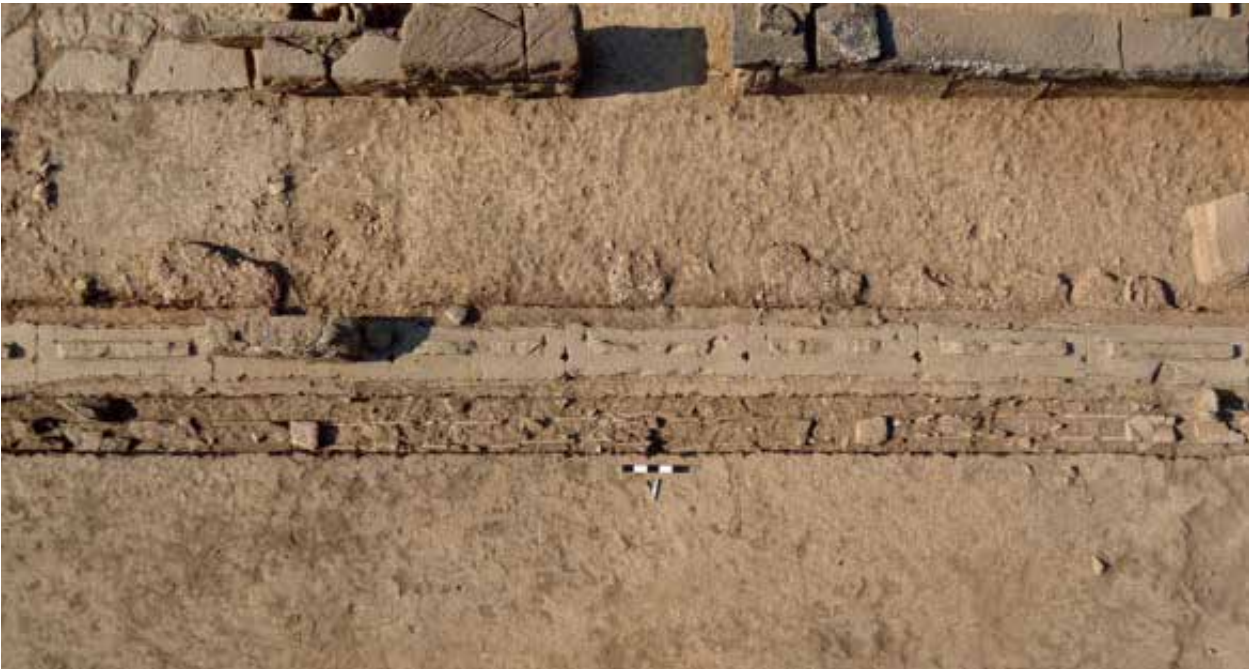
Fig. 2.c.15 Central part of proskenion stylobate, south is up. Rhombus-shaped dowel holes, curbs and circular cavities visible. South is up.

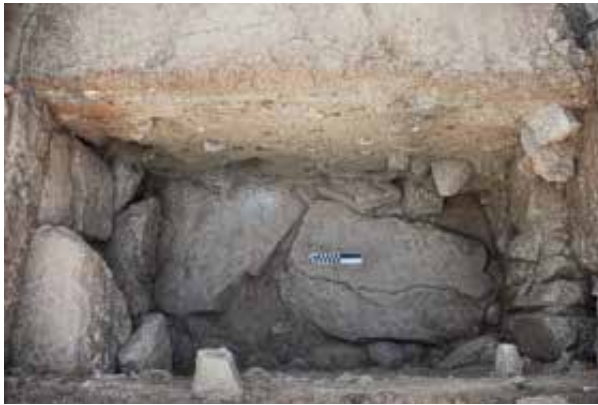
Fig. 2.c.16 Z29/M excavated to bed rock. Visible how foundation for Proskenion Stylobate rests on bed rock. From the west.
