1. Introduction

Rune Frederiksen and Olympia Vikatou

2. Description of the Remains of the Theatre

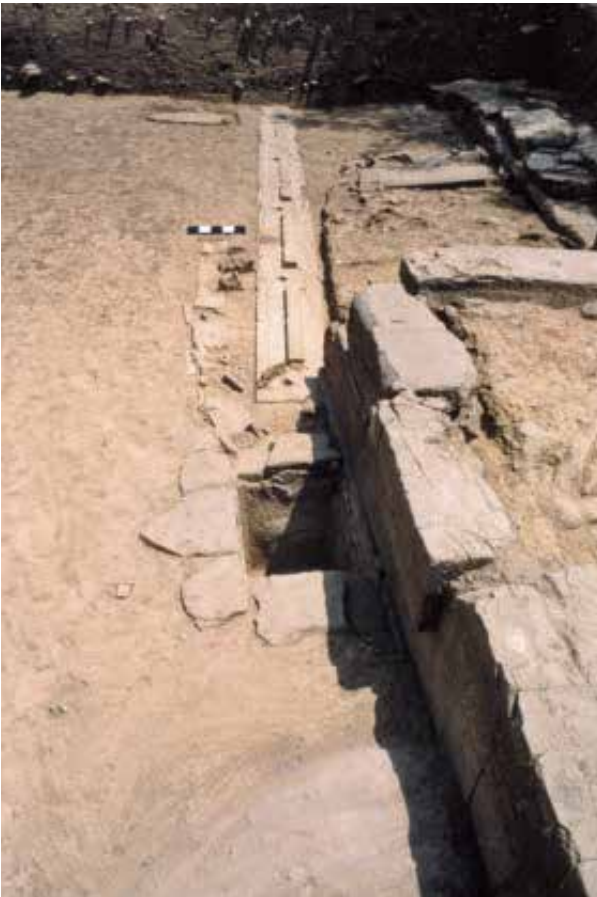
Fig. 2.c.17 West Ramp North Wall, West Water Basin and Proskenion Stylobate from the west. Part of column base (western corner pillar) still in situ on the stylobate.

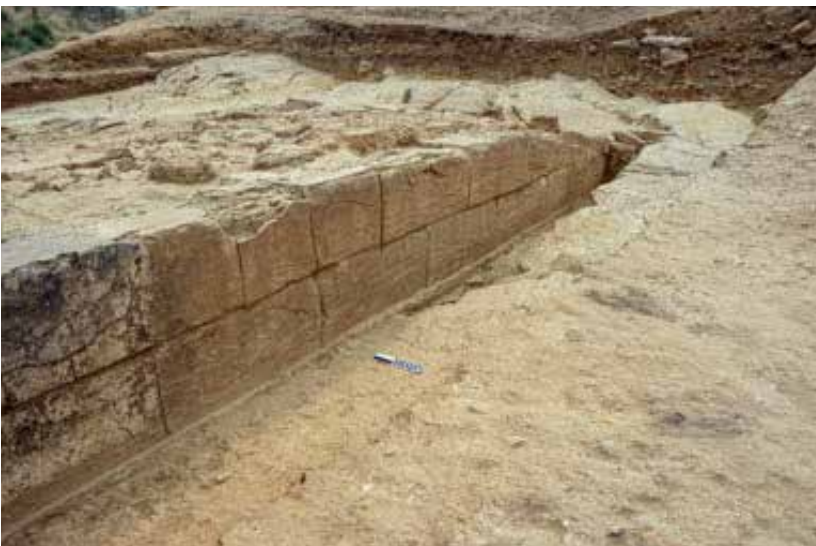
Fig. 2c.18 Detail of masonry of West Ramp North Wall. From the north east.

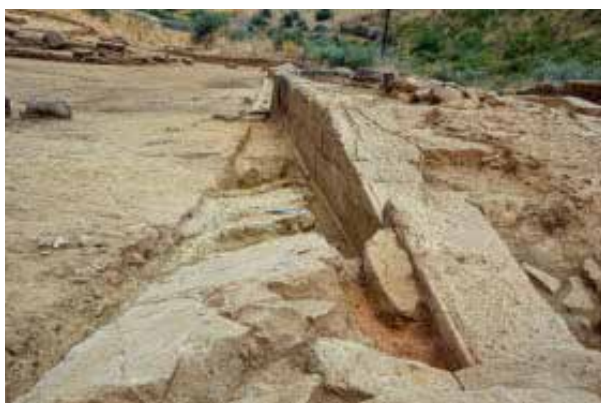
Fig. 2c.19 West Ramp North Wall from the west. Cover block with drafted edge in the foreground.

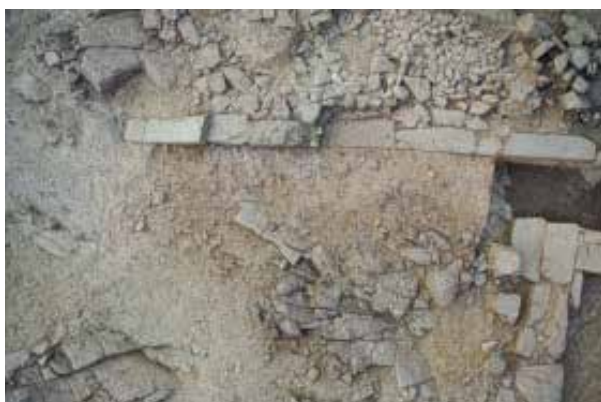
Fig. 2c.20 South part of West Ramp with West Ramp South Wall. On the right the west-most end of the Skene South Wall and the terrace wall AS26 are visible as are fill of the ramp and remains of stucco in the soil immediately south of WRSW. North is up.

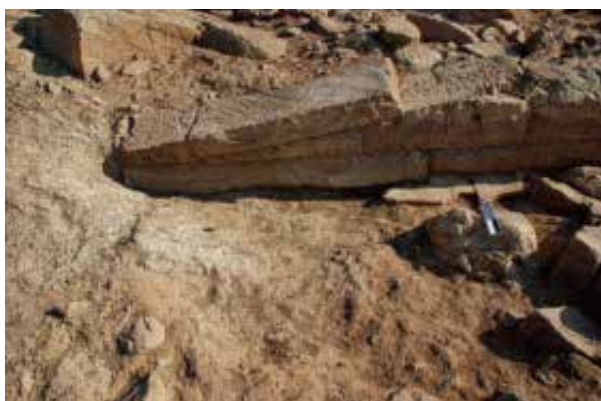
Fig. 2c.21 West end of West Ramp South Wall from the south. Masonry with cover blocks.

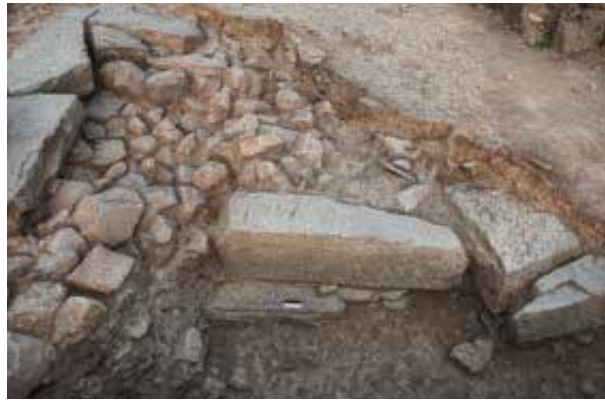
Fig. 2c.22 East Ramp, seen from the west, showing East Ramp North Wall to the left and fill of the ramp.

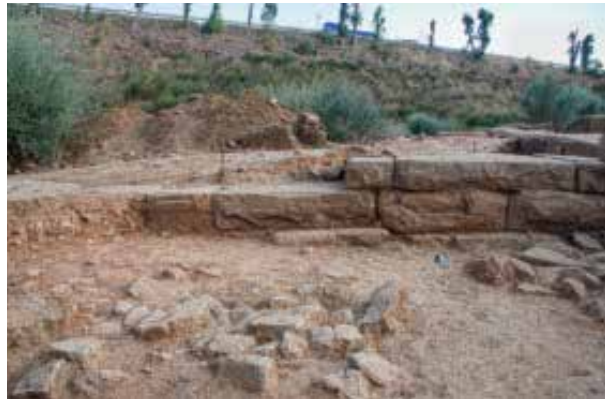
Fig. 2c.23 East Ramp North Wall from the north.

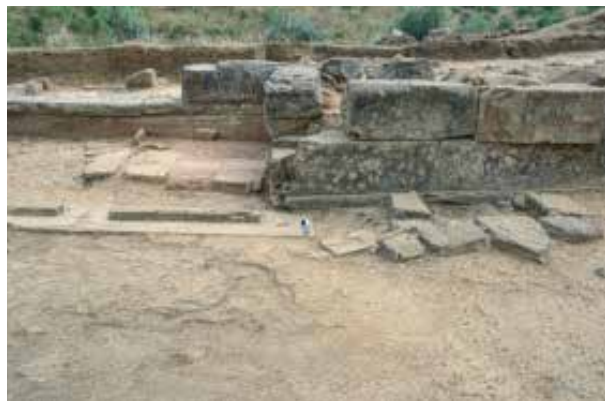
Fig. 2c.24 West Water Basin in surroundings. From the north.

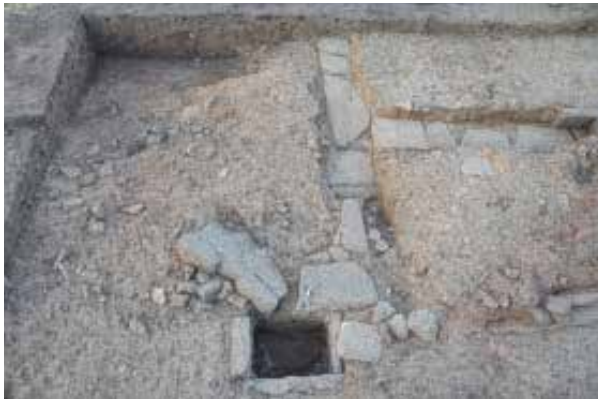
Fig. 2c.25 East Water Basin in surroundings. From the north.

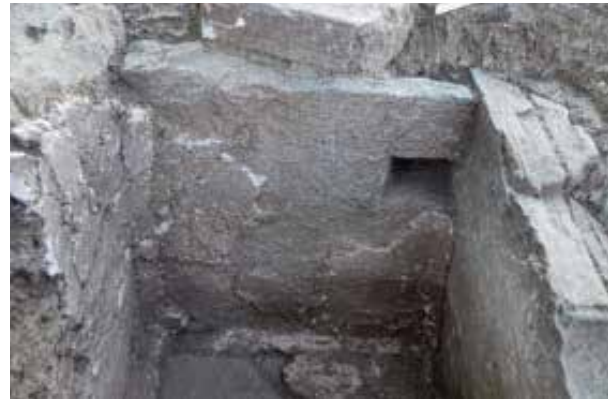
Fig. 2c.27 East Basin with square hole to receive water from West Basin via pipe. From the east.

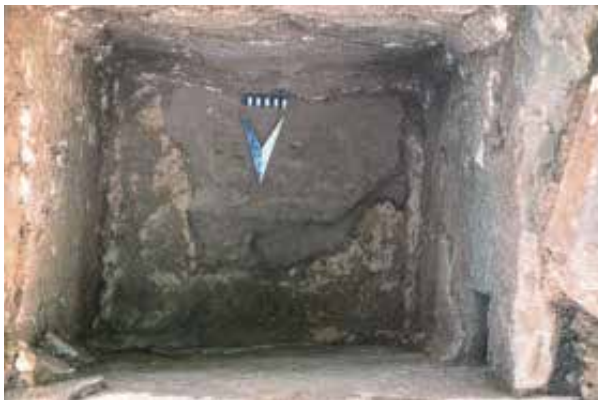
Fig. 2c.26 East Water Basin with hydraulic plaster.

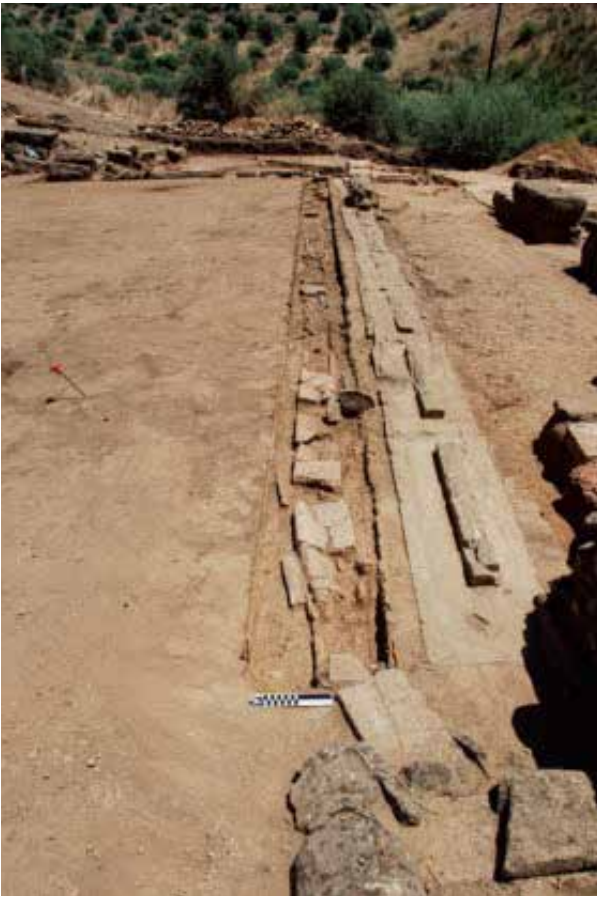
Fig. 2c.28 Terracotta Pipe running from West Water Basin to East Water Basin, from the west.

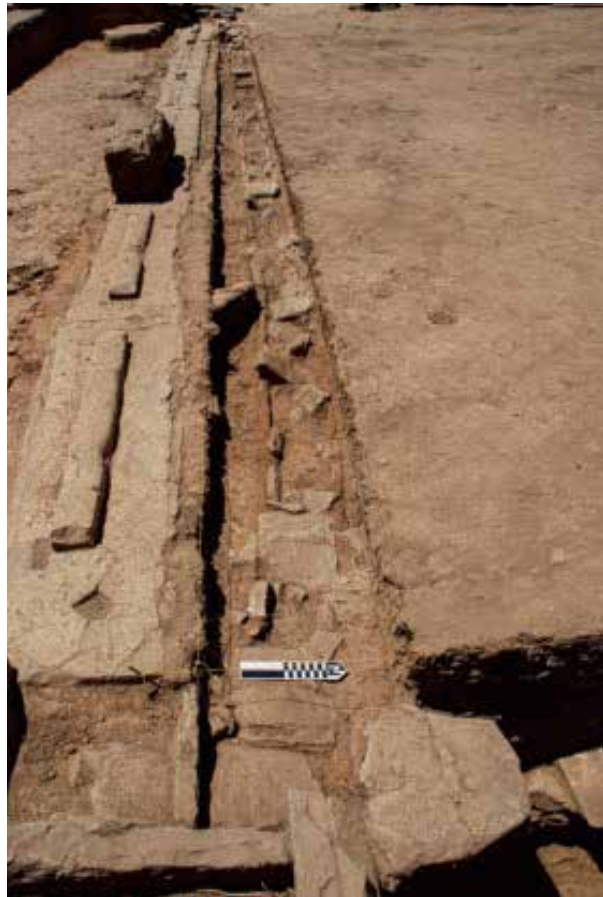
Fig. 2c.29 Terracotta Pipe running from West Water Basin to East Water Basin, from the east.

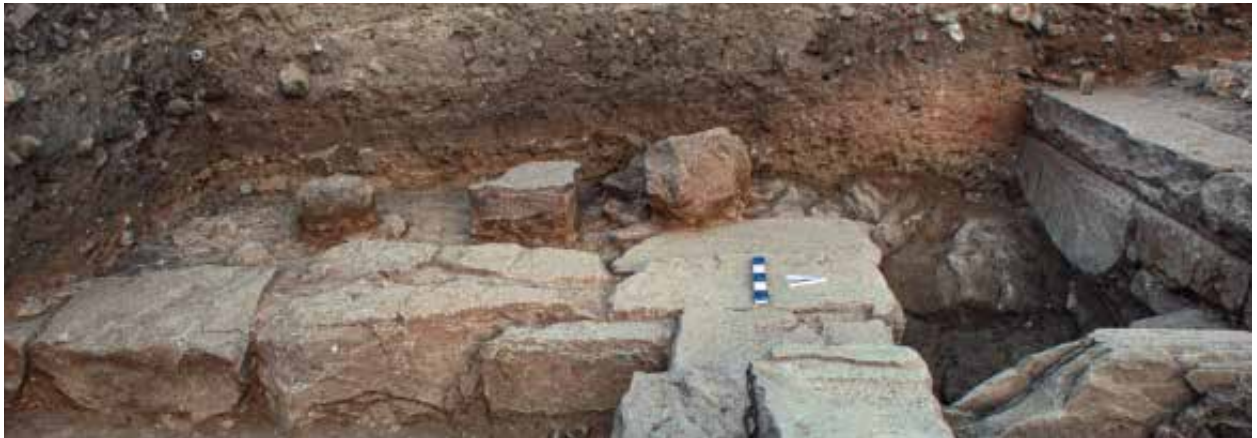
Fig. 2c.30 Terrace wall AS26 and (on the right) West Ramp South Wall from the east. Red or reddish layers visible above ancient ground level.

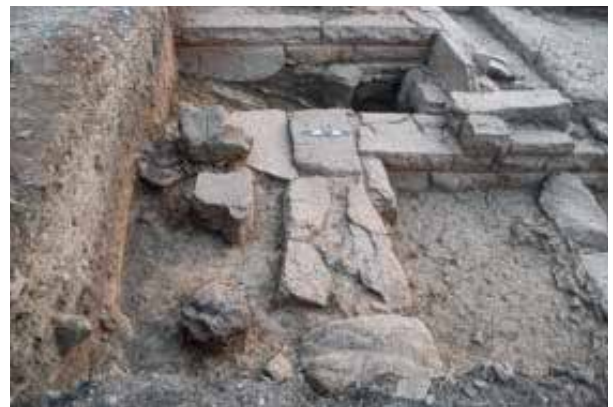
Fig. 2c.31 Terrace Wall AS26. Seen from the south. AS25 visible on the far right and West Ramp South Wall in top of picture.

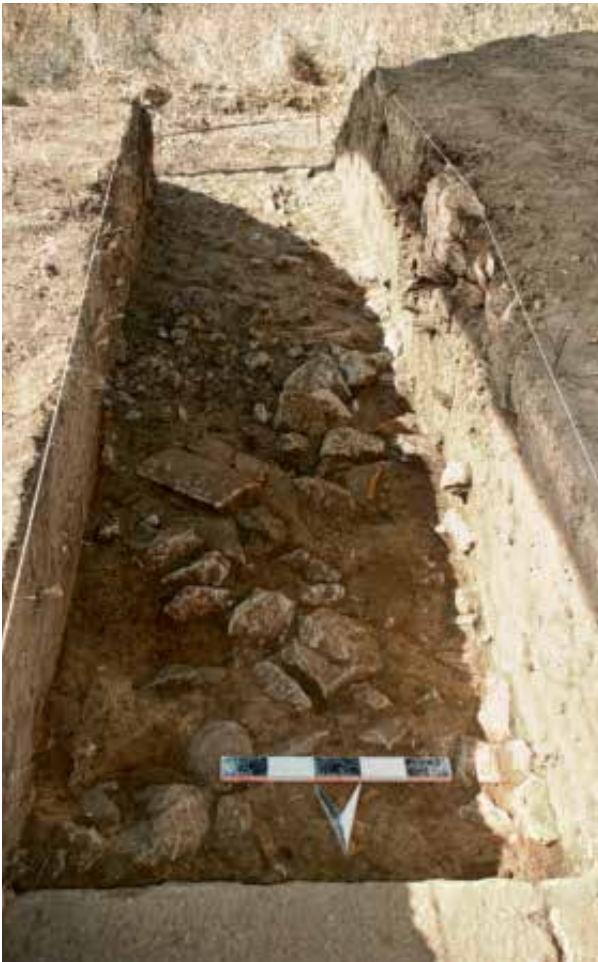
Fig. 2c.32 Layer of boulders and stones behind Skene South Wall, as cleaned in Z30.3 and seen from the north.

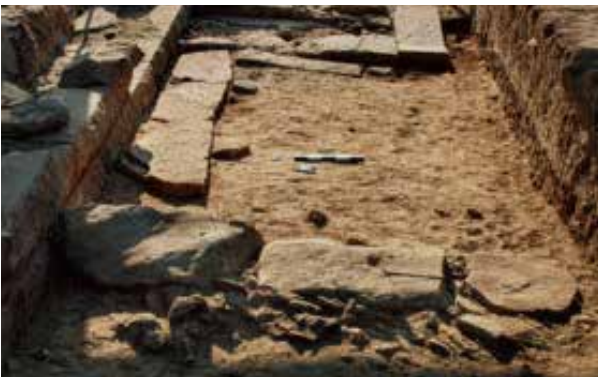
Fig. 2c.33 Row of slabs, AS24, connecting opening in Skene South Wall and foundation for stairway to upper storey. AS25 in the foreground. From the west.
